Town of Marshall

Historic Courthouse Renovation to Cultural and Community Center

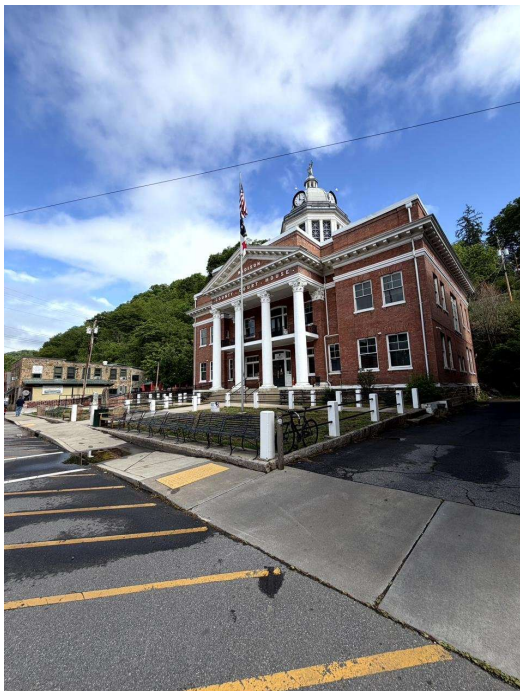
Figure 1 (left): view of the courthouse from across North Main Street showing perimeter fencing, monuments, and street-parking frontage.

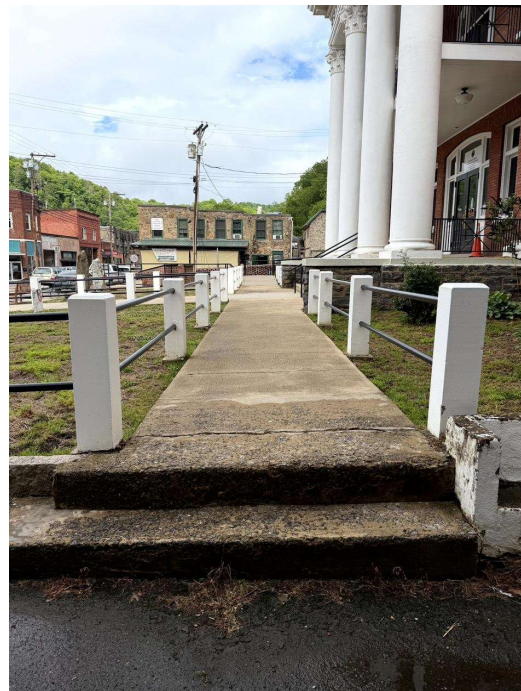
Figure 2 (right): view along the entrance plaza perimeter showing the concrete-post and metal pipe railing fence, wrought-iron benches, and deteriorated stone curb edge at the sidewalk.

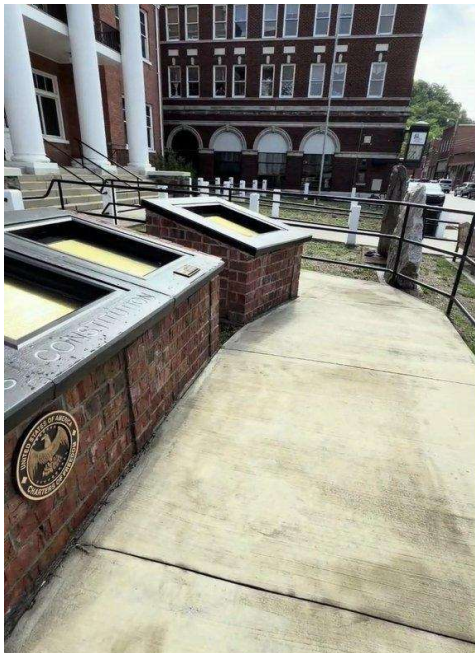
Figure 3: view of the existing monuments and articles in the entrance plaza, including the Charters of Freedom installation (foreground, with the United States seal medallion and brass document plaques on brick pedestals) and two rock monuments (background right).

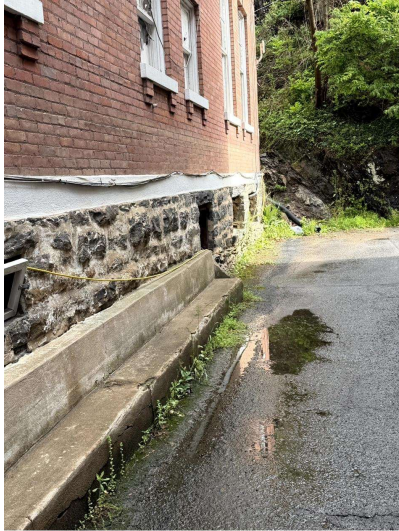
Figure 5: view of the east-side access drive showing pavement deterioration, ponding along the foundation interface, vegetation encroachment, and lack of positive drainage. A basement window / vent opening is visible at grade in the stone foundation wall.

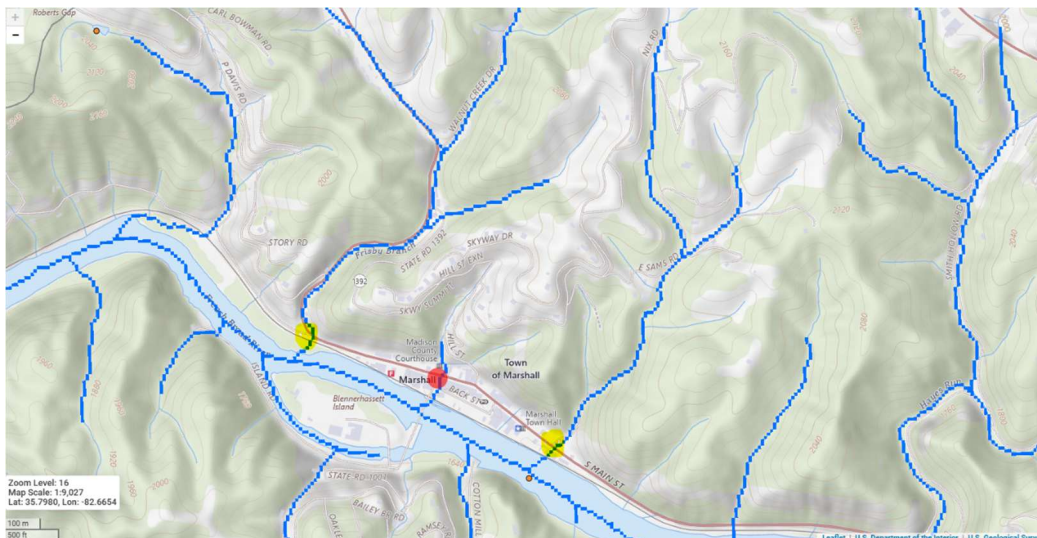
KCI was not originally scoped to provide an assessment or recommendation regarding the interception, diversion, or management of this upland runoff around the building, and no stormwater modeling, drainage study, or grading analysis to address the receiving drainage area has been performed as part of this report. During recent coordination with CPL, the project team identified that stormwater management around the building could be considered as part of the overall revitalization in support of the CDBG-DR grant application and the Town's goal of resiliency for the renovated facility, though the

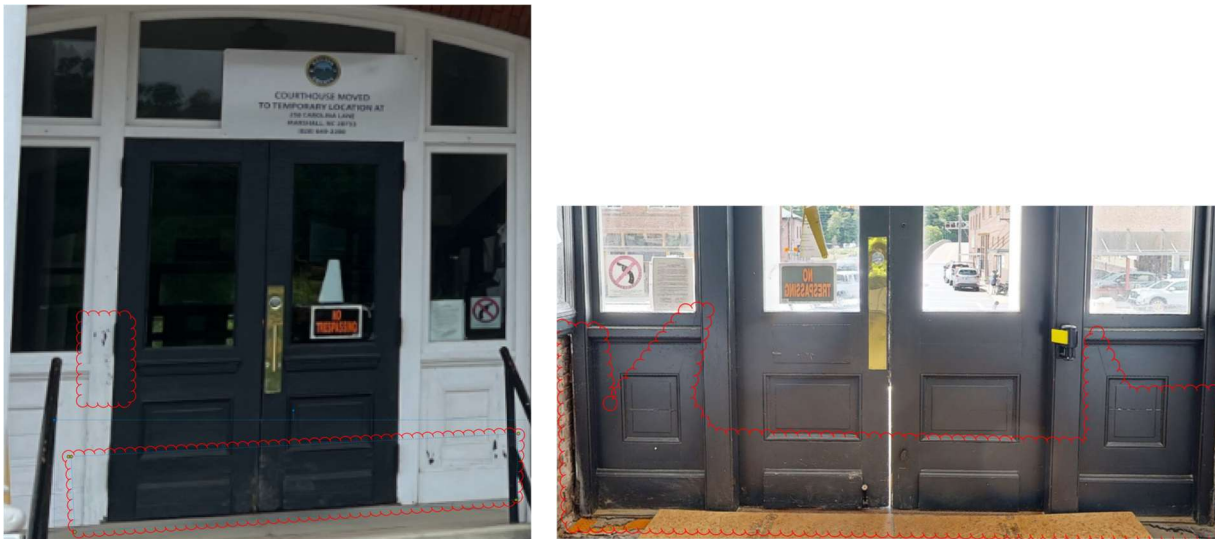
Figure 7: Photos of the original main entrance doors with special attention to visible water damage including rotten wood on the doors and framing elements, visible fissures in wood panels, large gaps, and rotten subfloor elements.

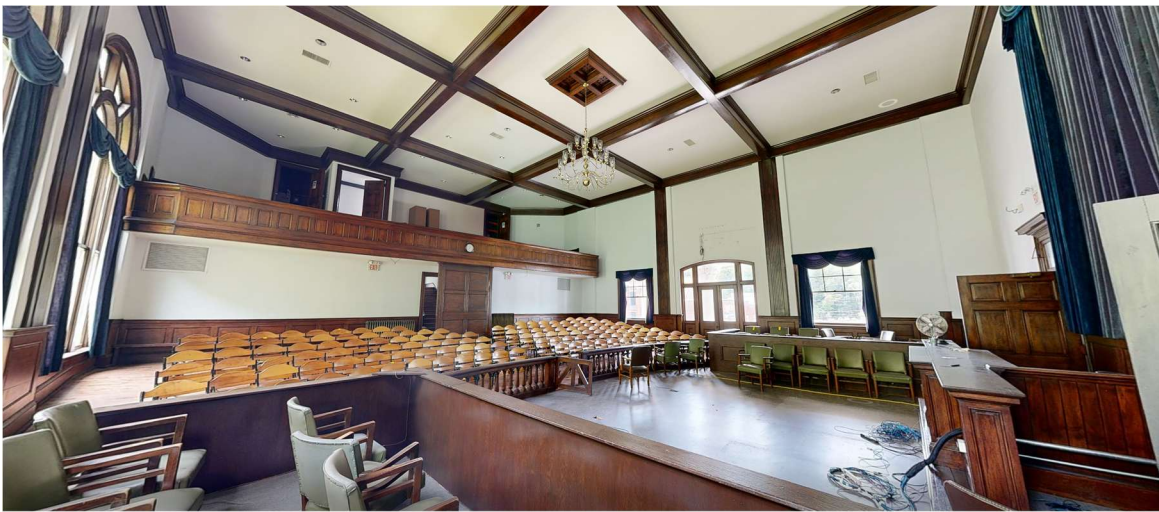
Figure 8: Interior of the existing courtroom and proposed performance hall space.

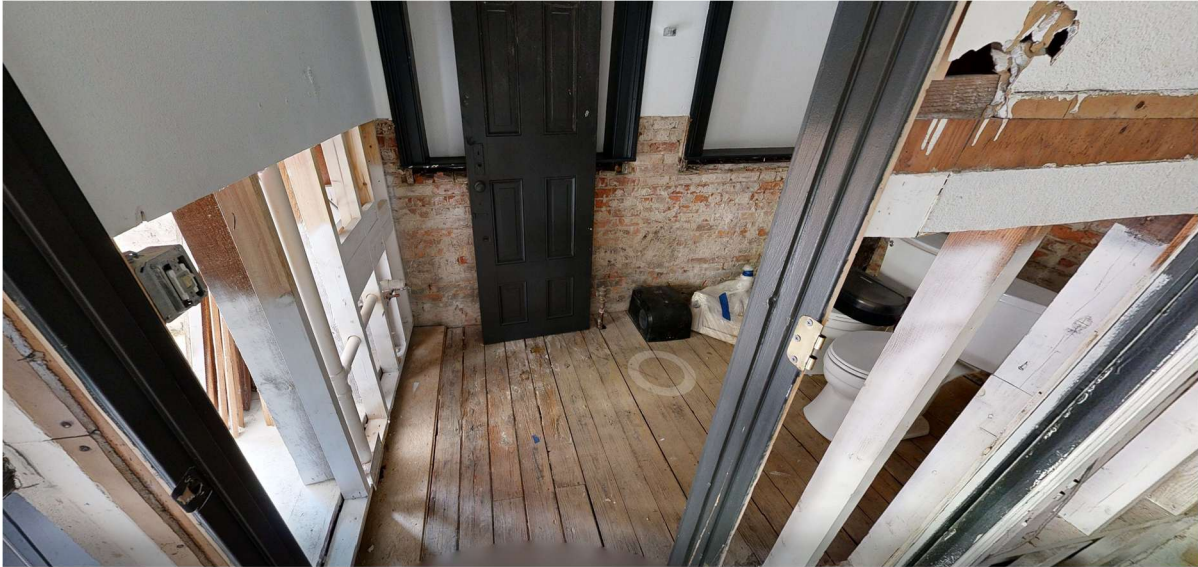
Figure 11: Existing restroom on main level.

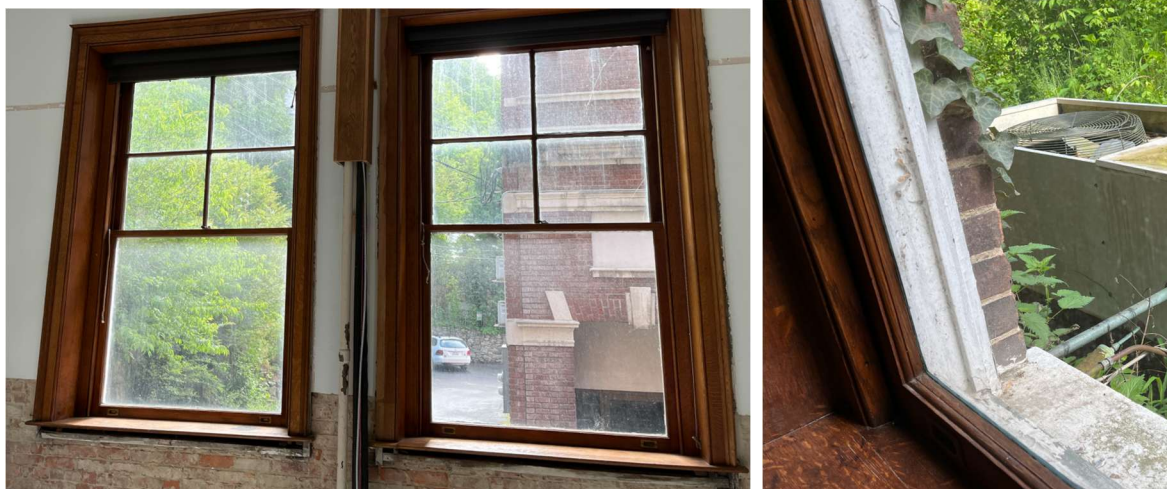
Figure 13: Example of existing single pane windows to be replaced.

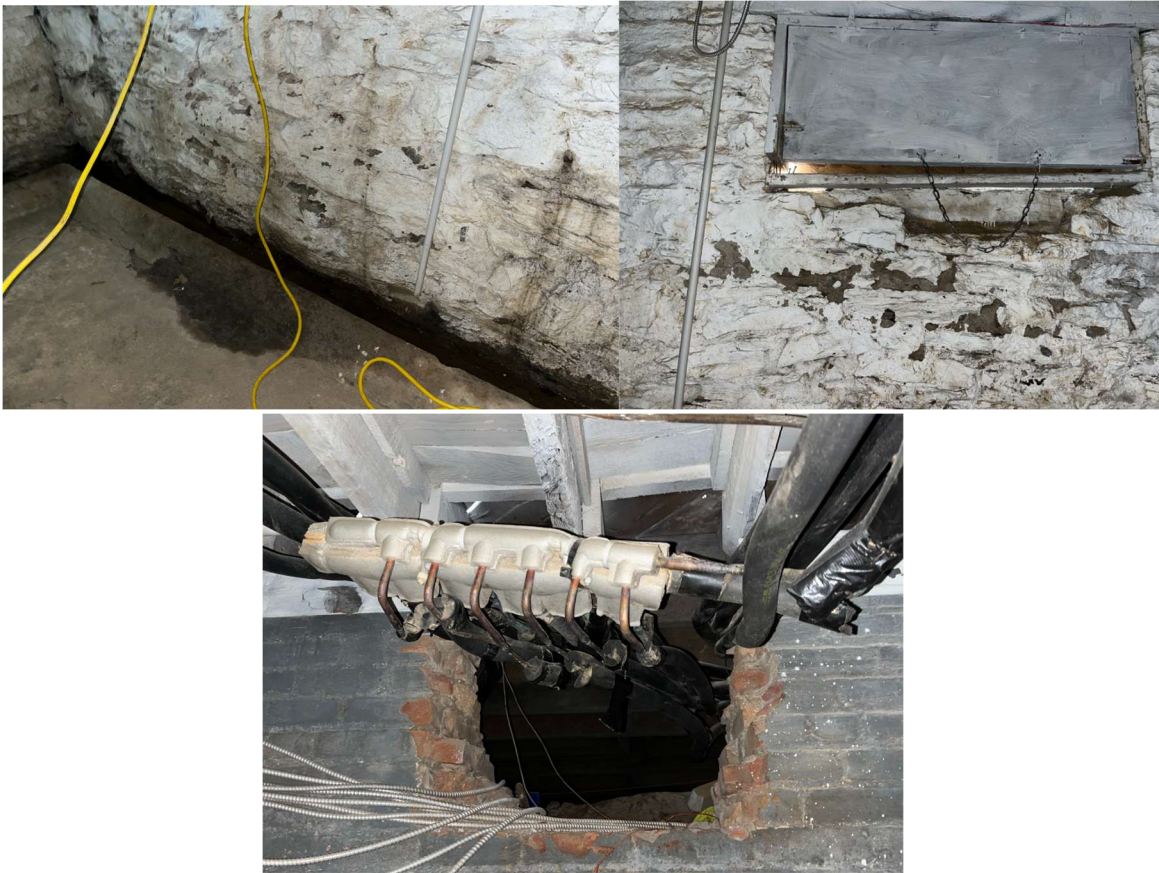
Figure 14: Examples of water infiltration and related damage in the basement/foundation walls.

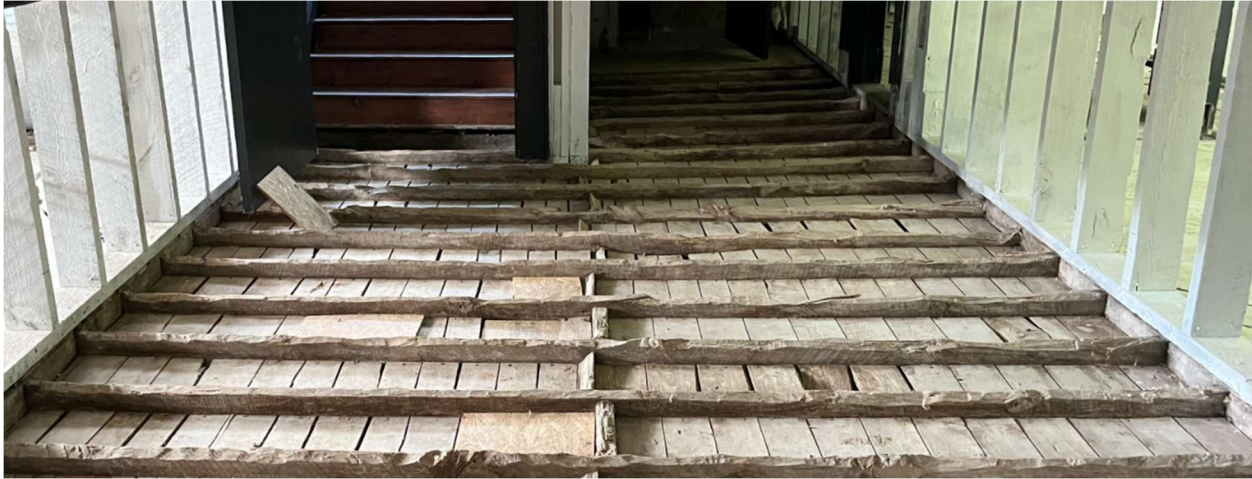
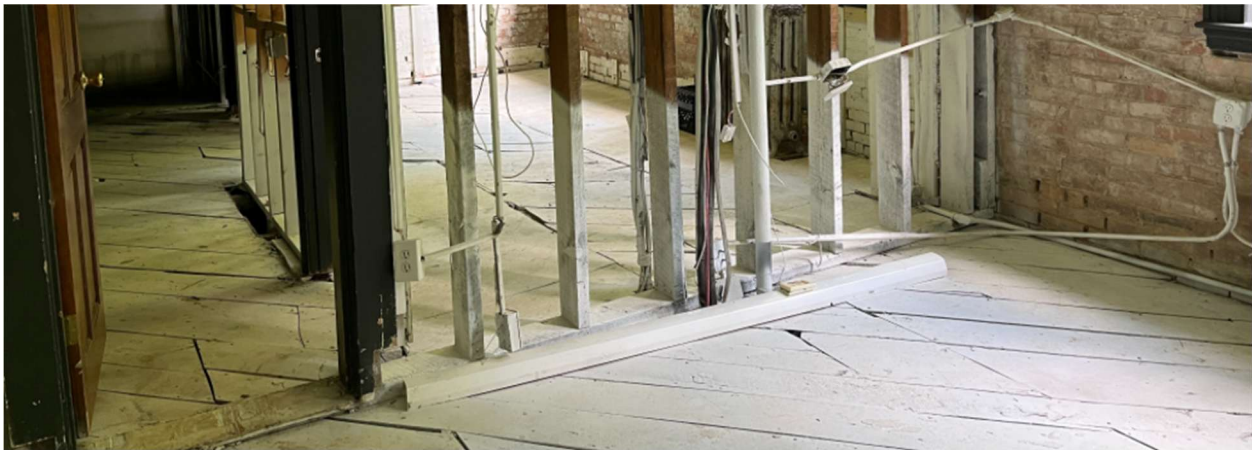
Figure 15: Example of existing floor construction (Top) with Wood Lath Strips and Rough-Cut Wood Joists. Example of existing sub floor (Bottom) including Wood plan decking installed at 45 degrees to the Wood Joists.

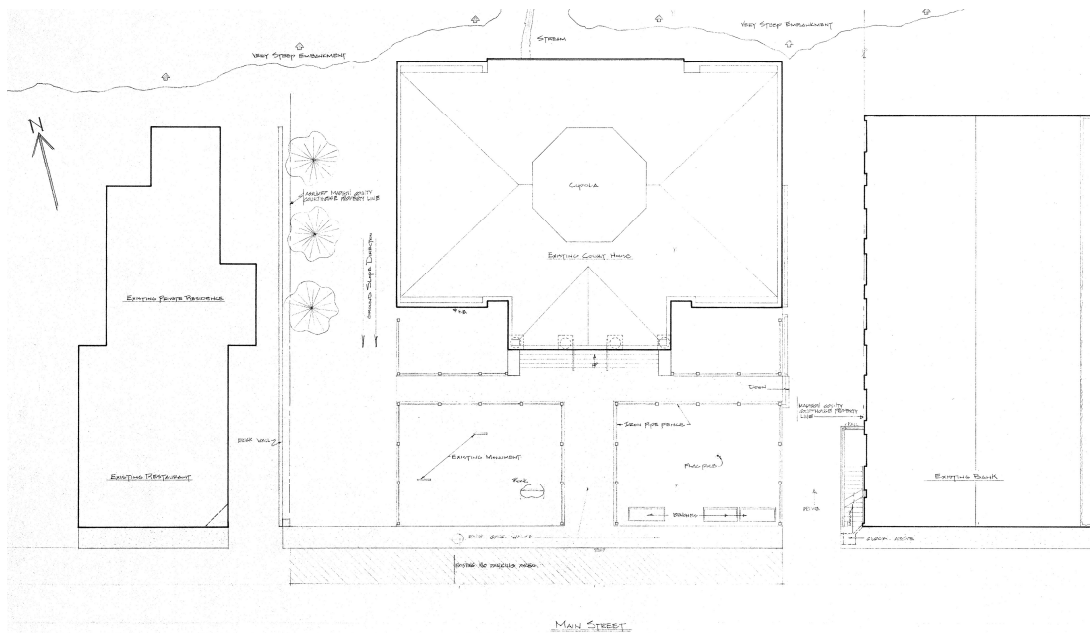
Figure 16: Site Plan (obtained from Renovations by Woodard and Roberts Architects)

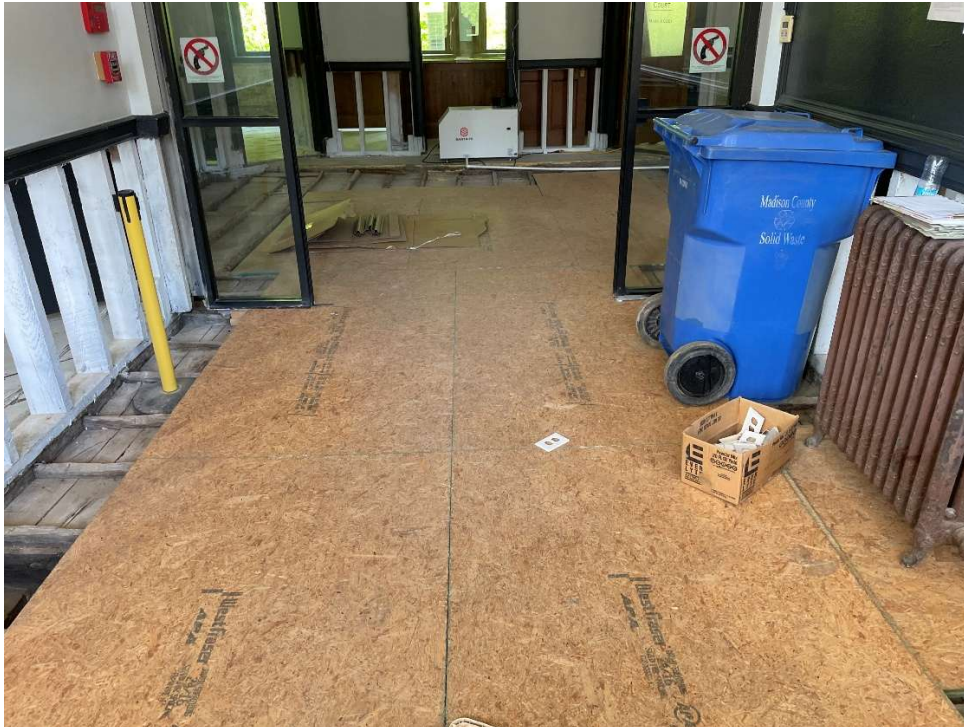
Figure 17: First Floor View at Front Door Entry to Courthouse

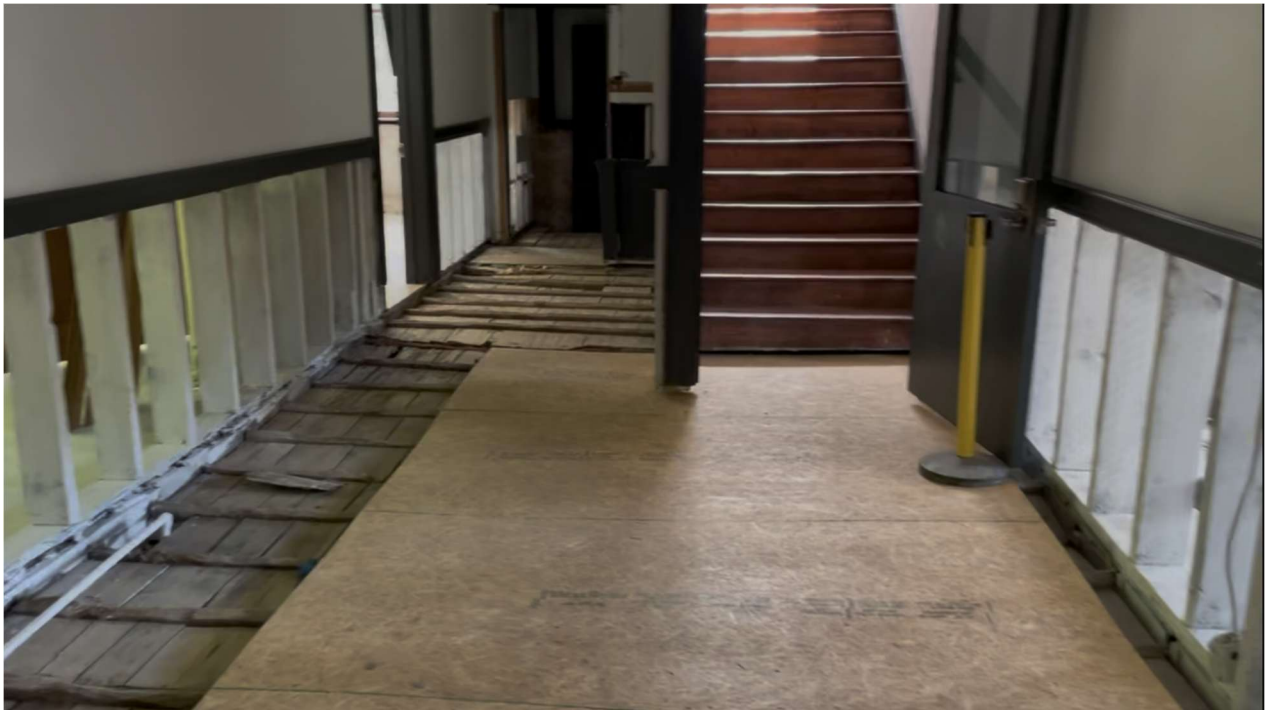
Figure 18: First Floor - Rear of Entry – Looking East

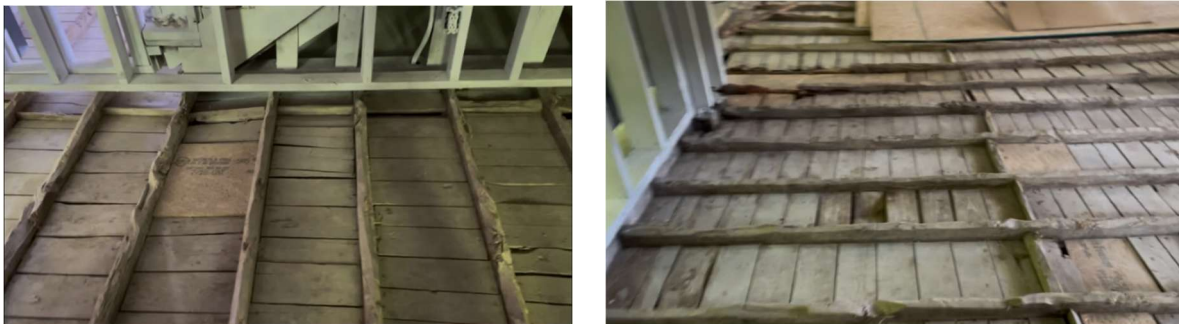
Figures 20 & 21: First Floor - Main Hall Rear of Entry – Damaged Floor Joists

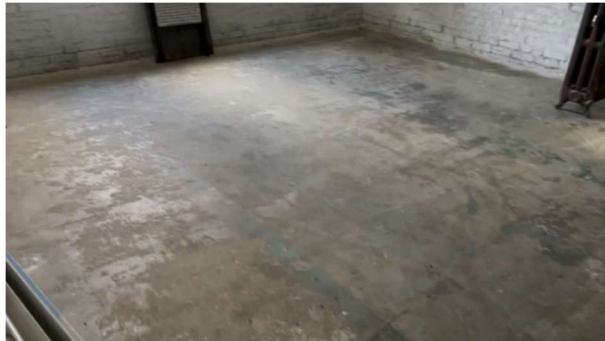
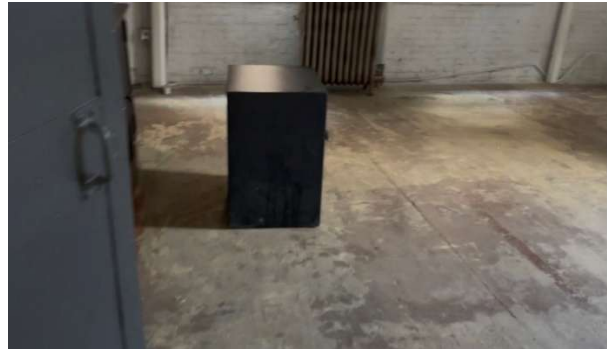
Figures 22 & 23: First Floor - Front West Room – Front East Room - Concrete Slab Floor

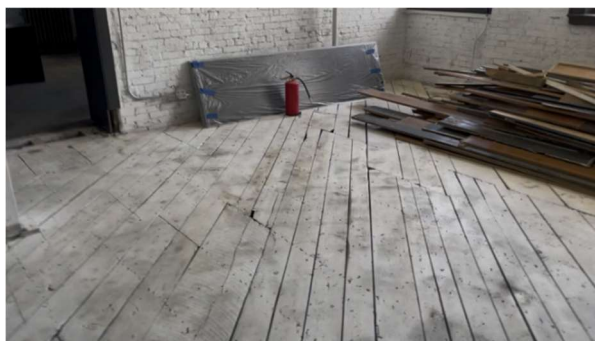
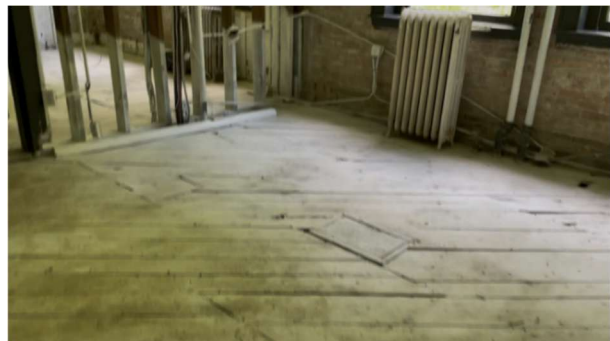
Figures 24 & 25: First Floor – Front Room – Rear Room - Horizontal Plank Floorboards

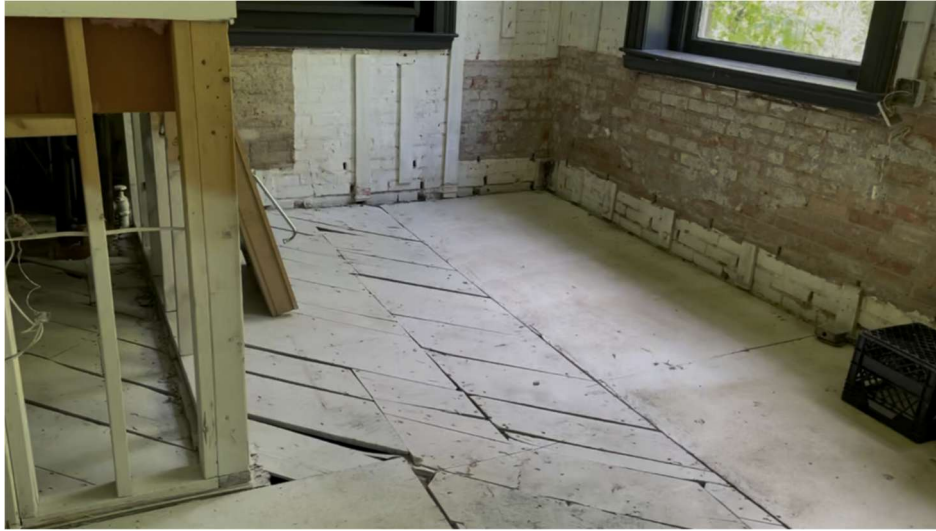
Figure 26: First Floor - Rear Room – Mix of Plank Floorboards and Sheathing

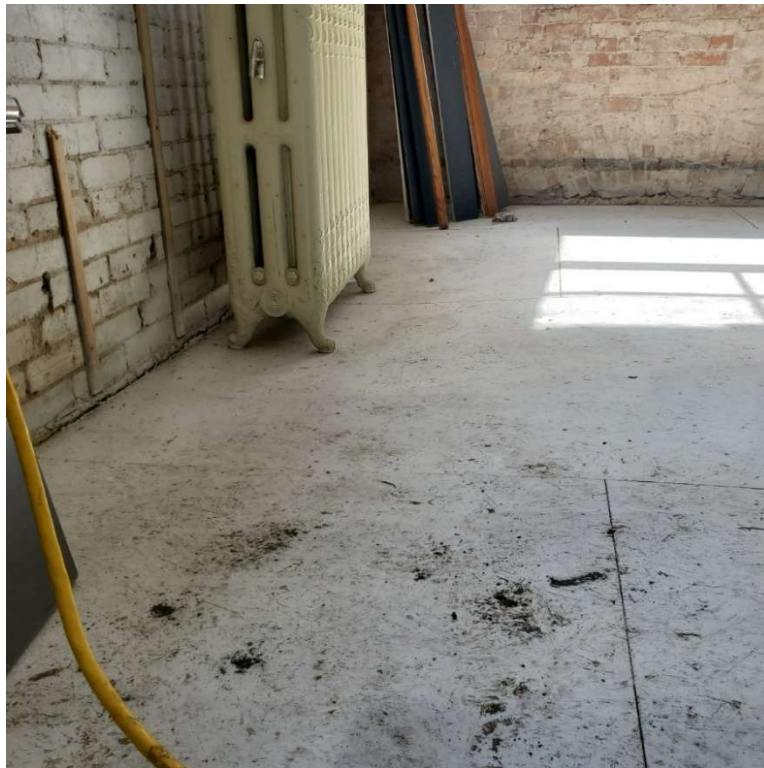
Figure 27: First Floor - Rear East Room – Low Spot in Subfloor at Radiator Heater

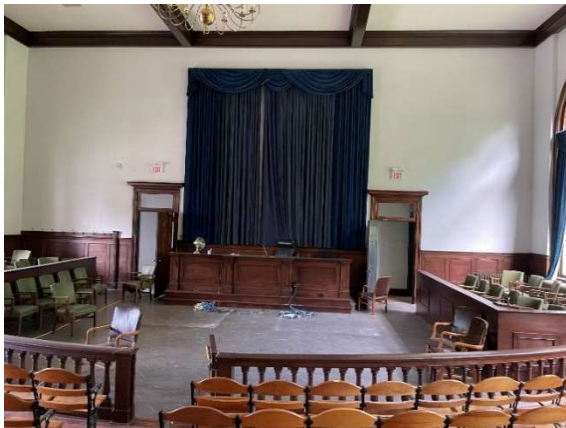
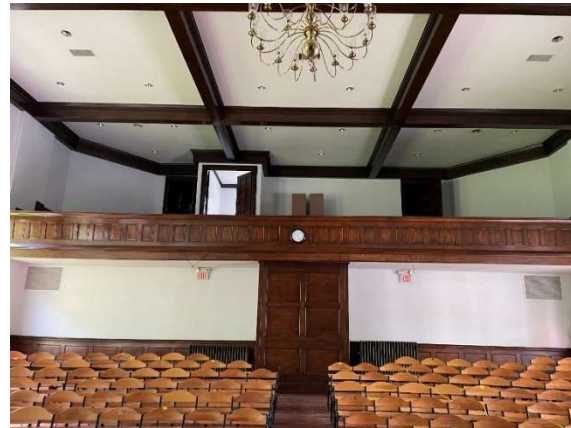
Figure 28: Second Floor – Courtroom Looking West *Figure 29: Second Floor – Balcony Looking East*

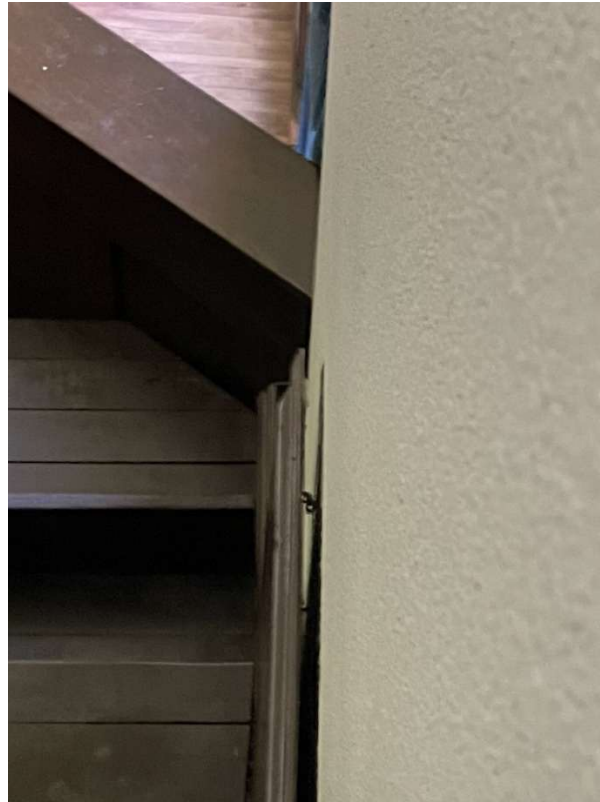
Figure 30: Second Floor – Balcony Connection at Rear Wall Separating

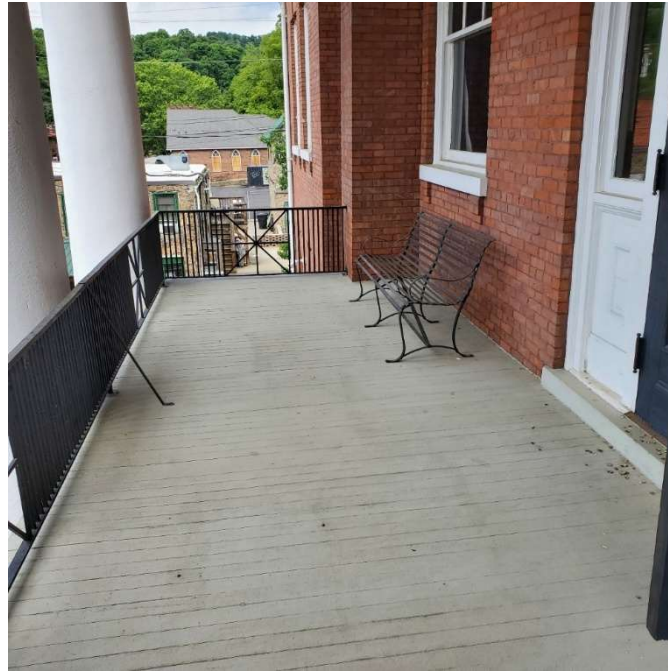
Figure 31: Second Floor – Front Porch adjacent to Courtroom

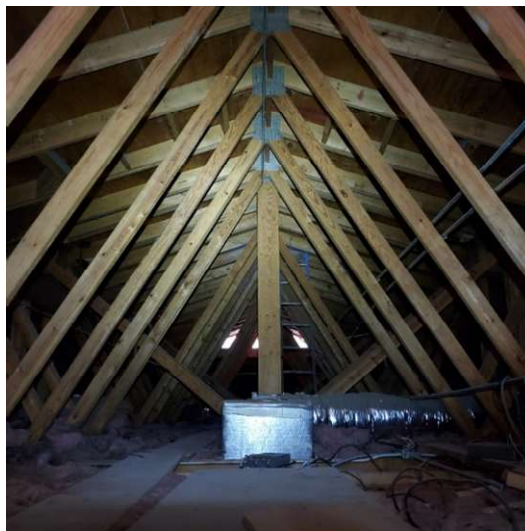
Figure 34: Attic Space – Wood Truss

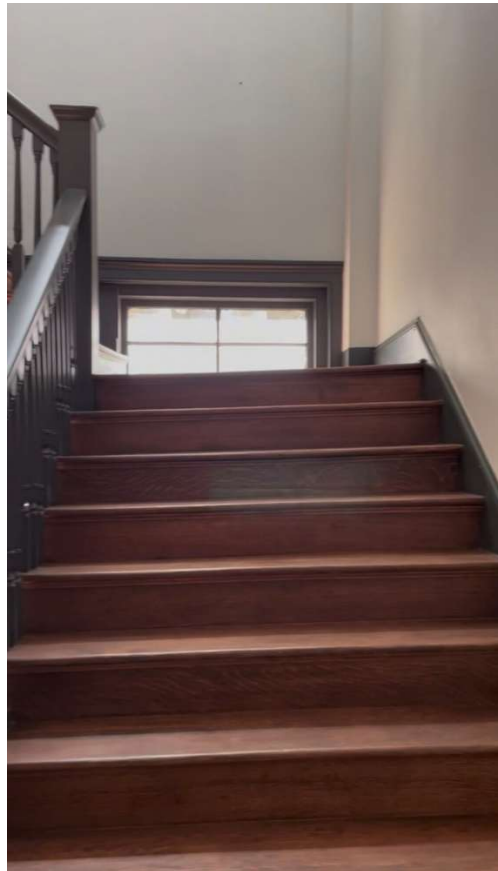
Figure 35: East End Stairs – Sinking Post at Inside Corner

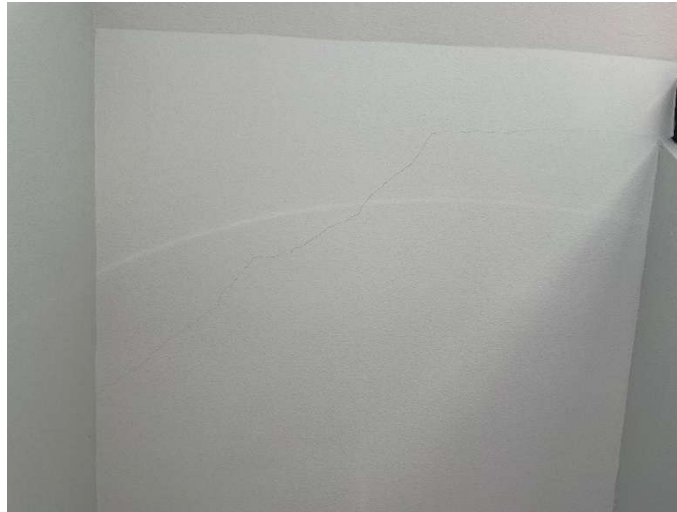
Figure 36: Cracking in Gypsum Ceiling adjacent to Sinking Post at Stair Landing

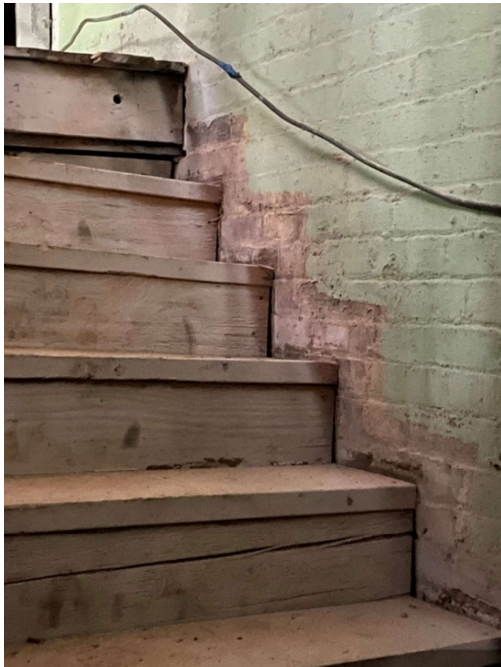
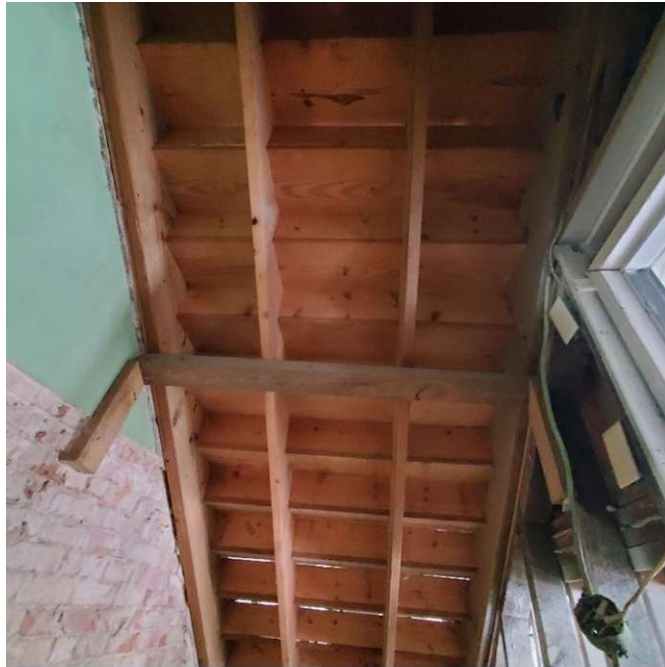
Figure 37: Stairs to Basement Level Figure 38: Underside of Stairs to Basement Level

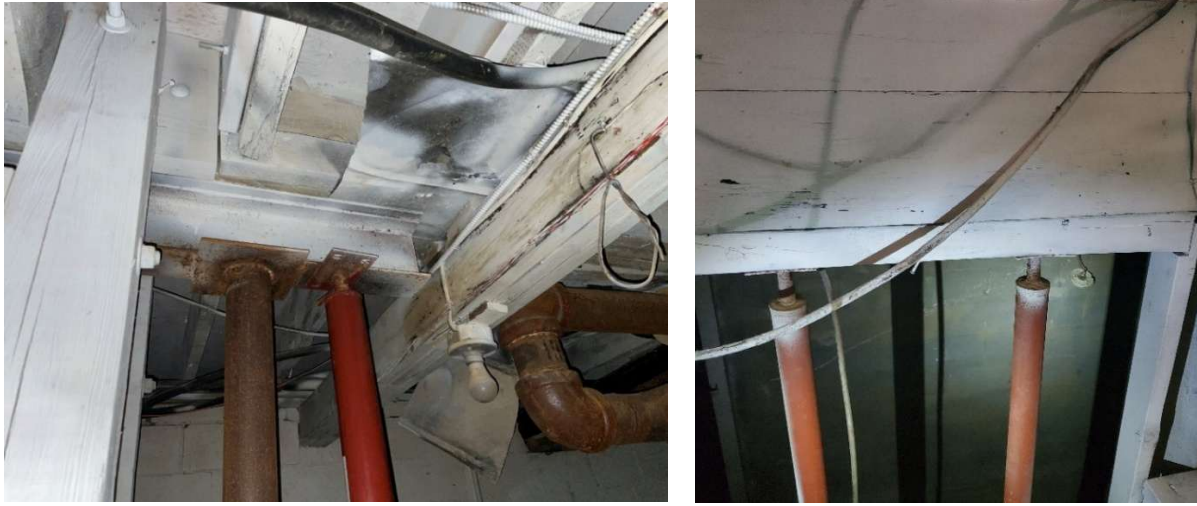
Figure 39 & 40: Pipe Jack Supports in Basement Level

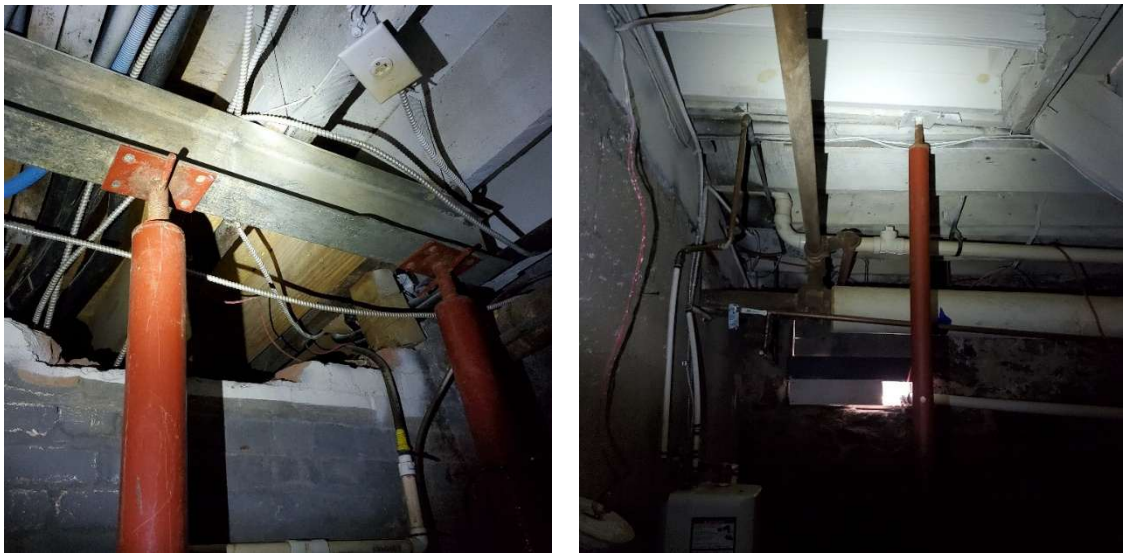
Figure 41 & 42: Pipe Jack Supports in Basement Level

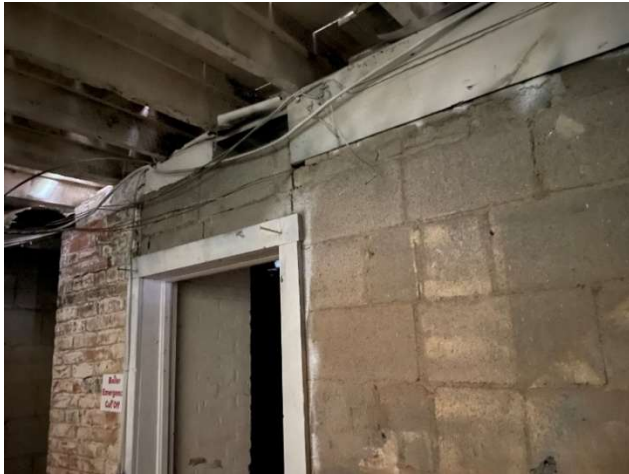
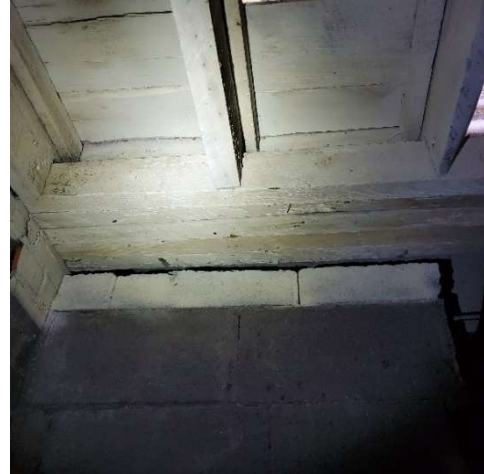
Figures 43 & 44: CMU Walls at Basement Level

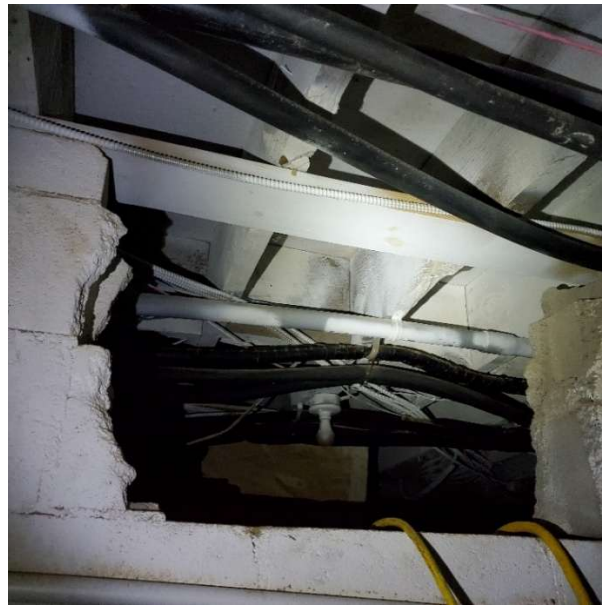
Figure 45: Large Void in CMU Wall Support Floor Joist

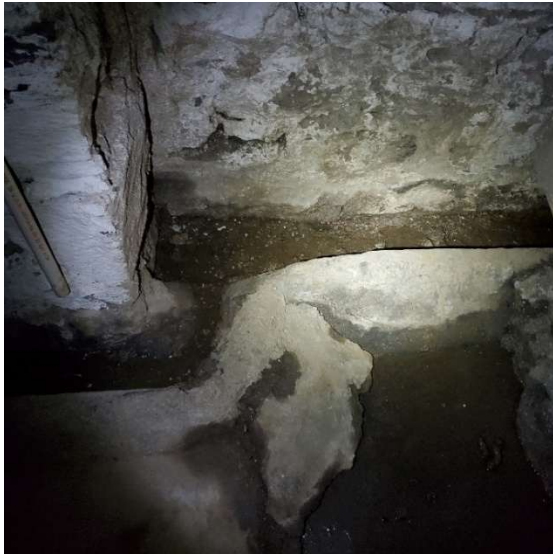
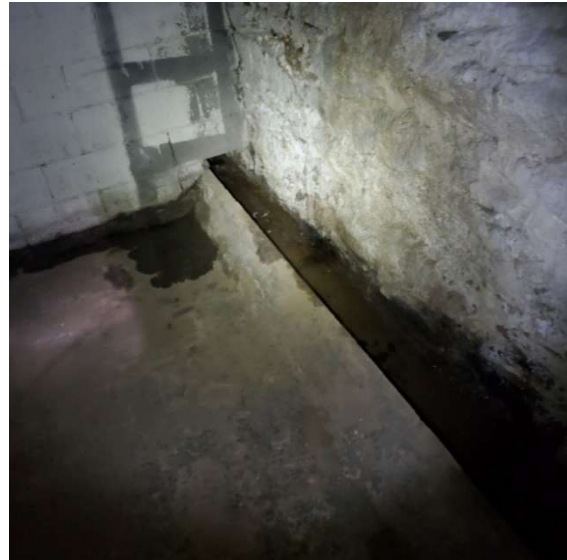
Figures 46-47: Water Trench at Inside Face of Retaining Wall

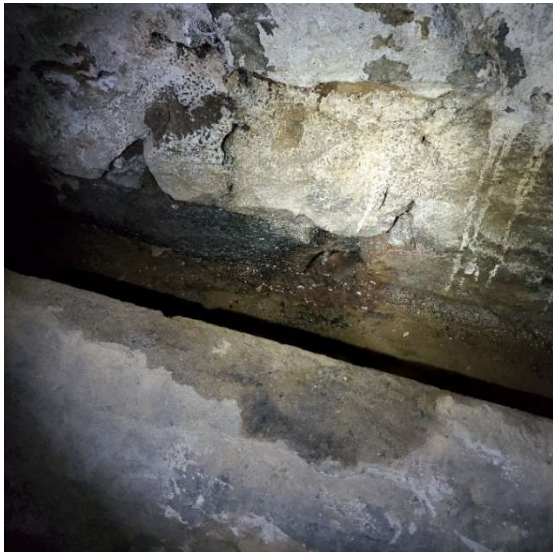
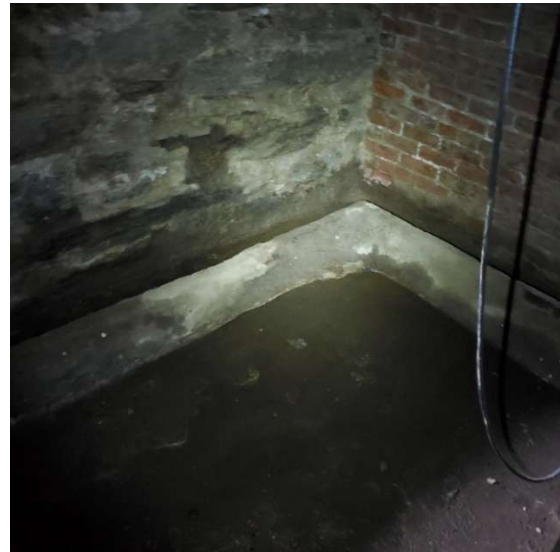
Figures 48-49: Water Trench at Inside Face of Retaining Wall

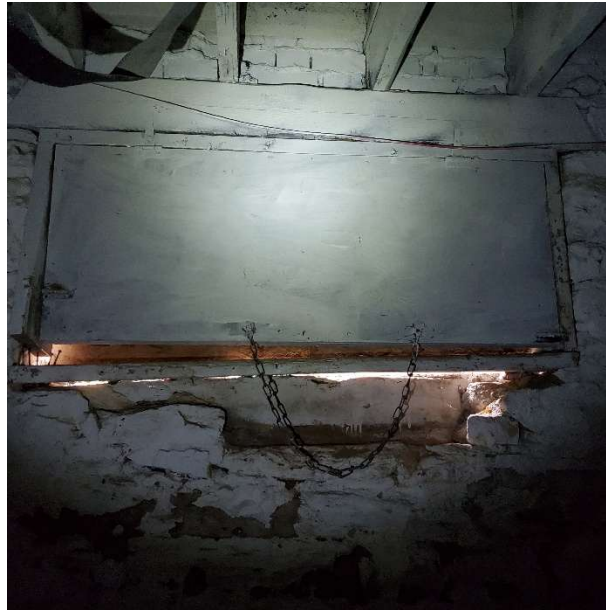
Figure 50: Access Hatch to Exterior

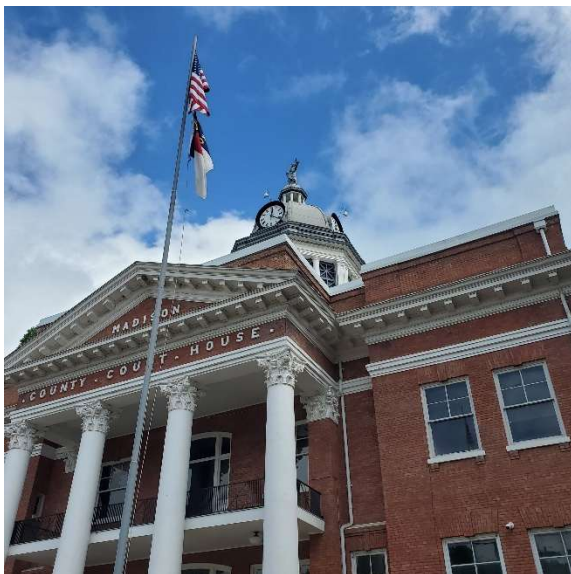
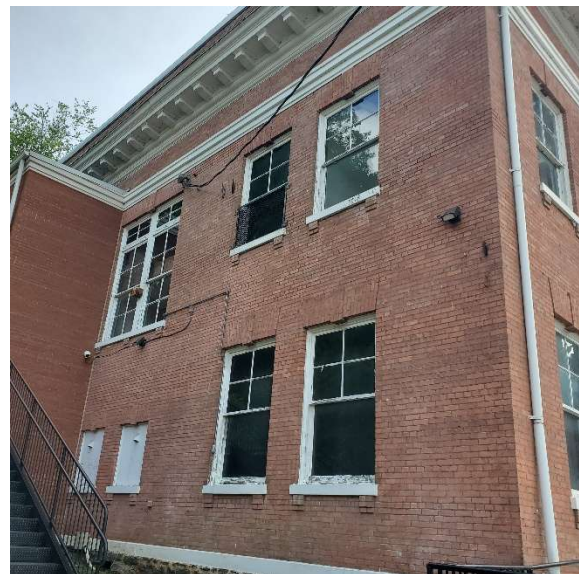
Figures 51 & 52: Exterior Brick – South (Front) Wall and West (End) Wall

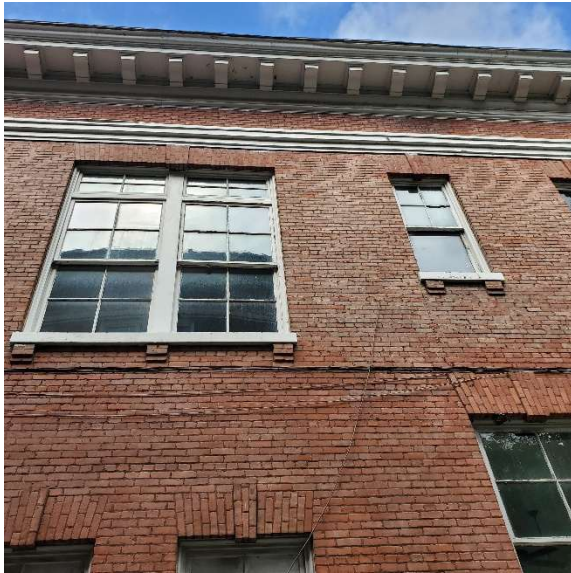
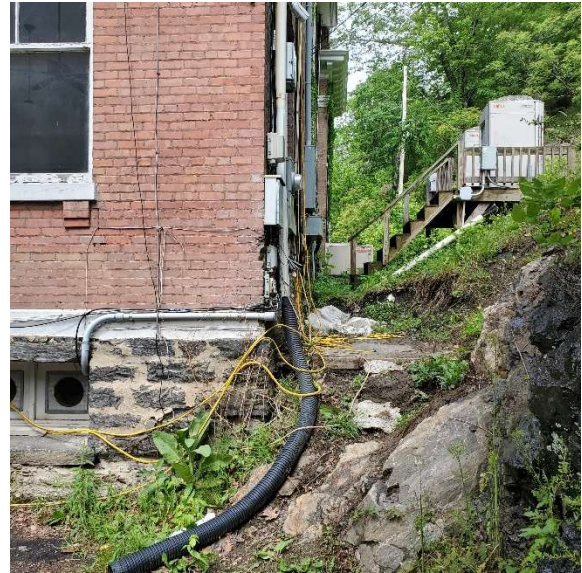
Figures 53 & 54: Exterior Brick – East (End) Wall and Northeast Corner

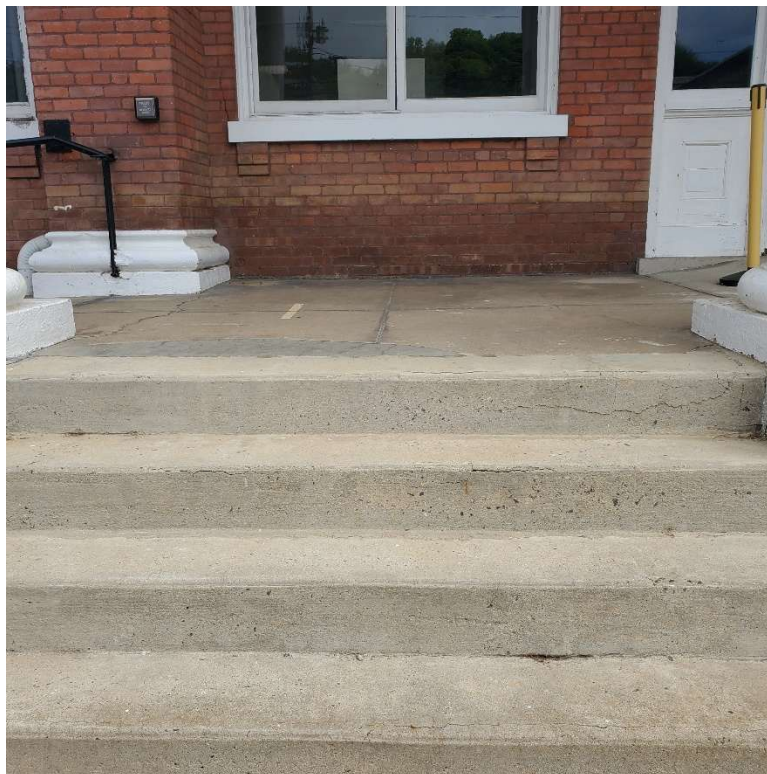
Figure 55: Front Steps Cracking in Concrete

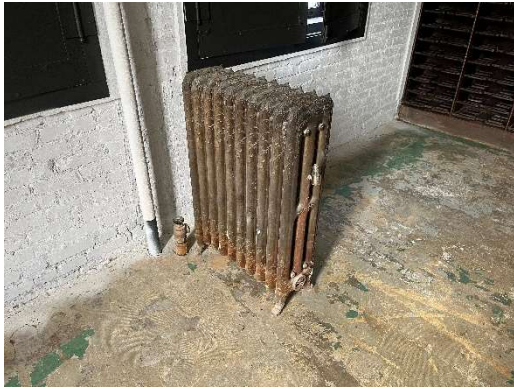
Figure 56 - Radiator.

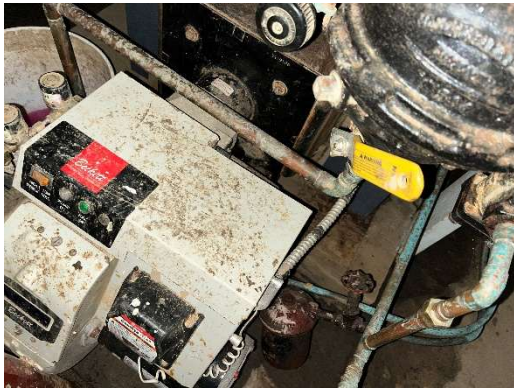
Figure 58 - Boiler Burner

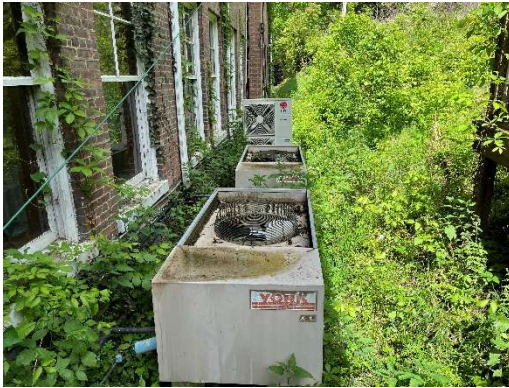
Figure 59 - Condensing unit on ground.

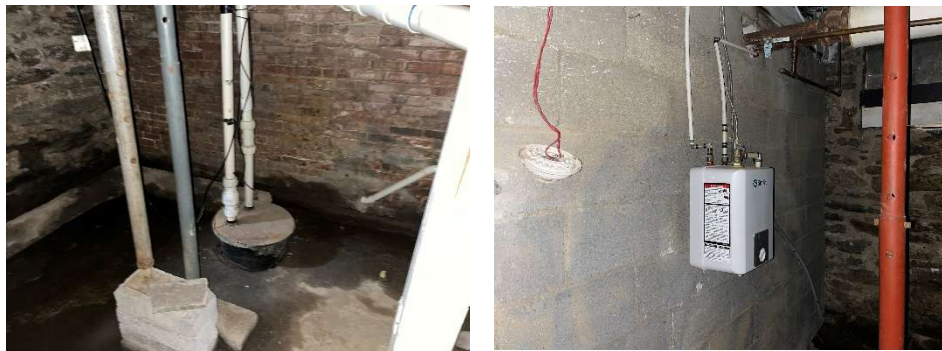
Basement sump pump and wall mounted instantaneous water heater.
