Town of Marshall

Historic Courthouse Renovation to Cultural and Community Center

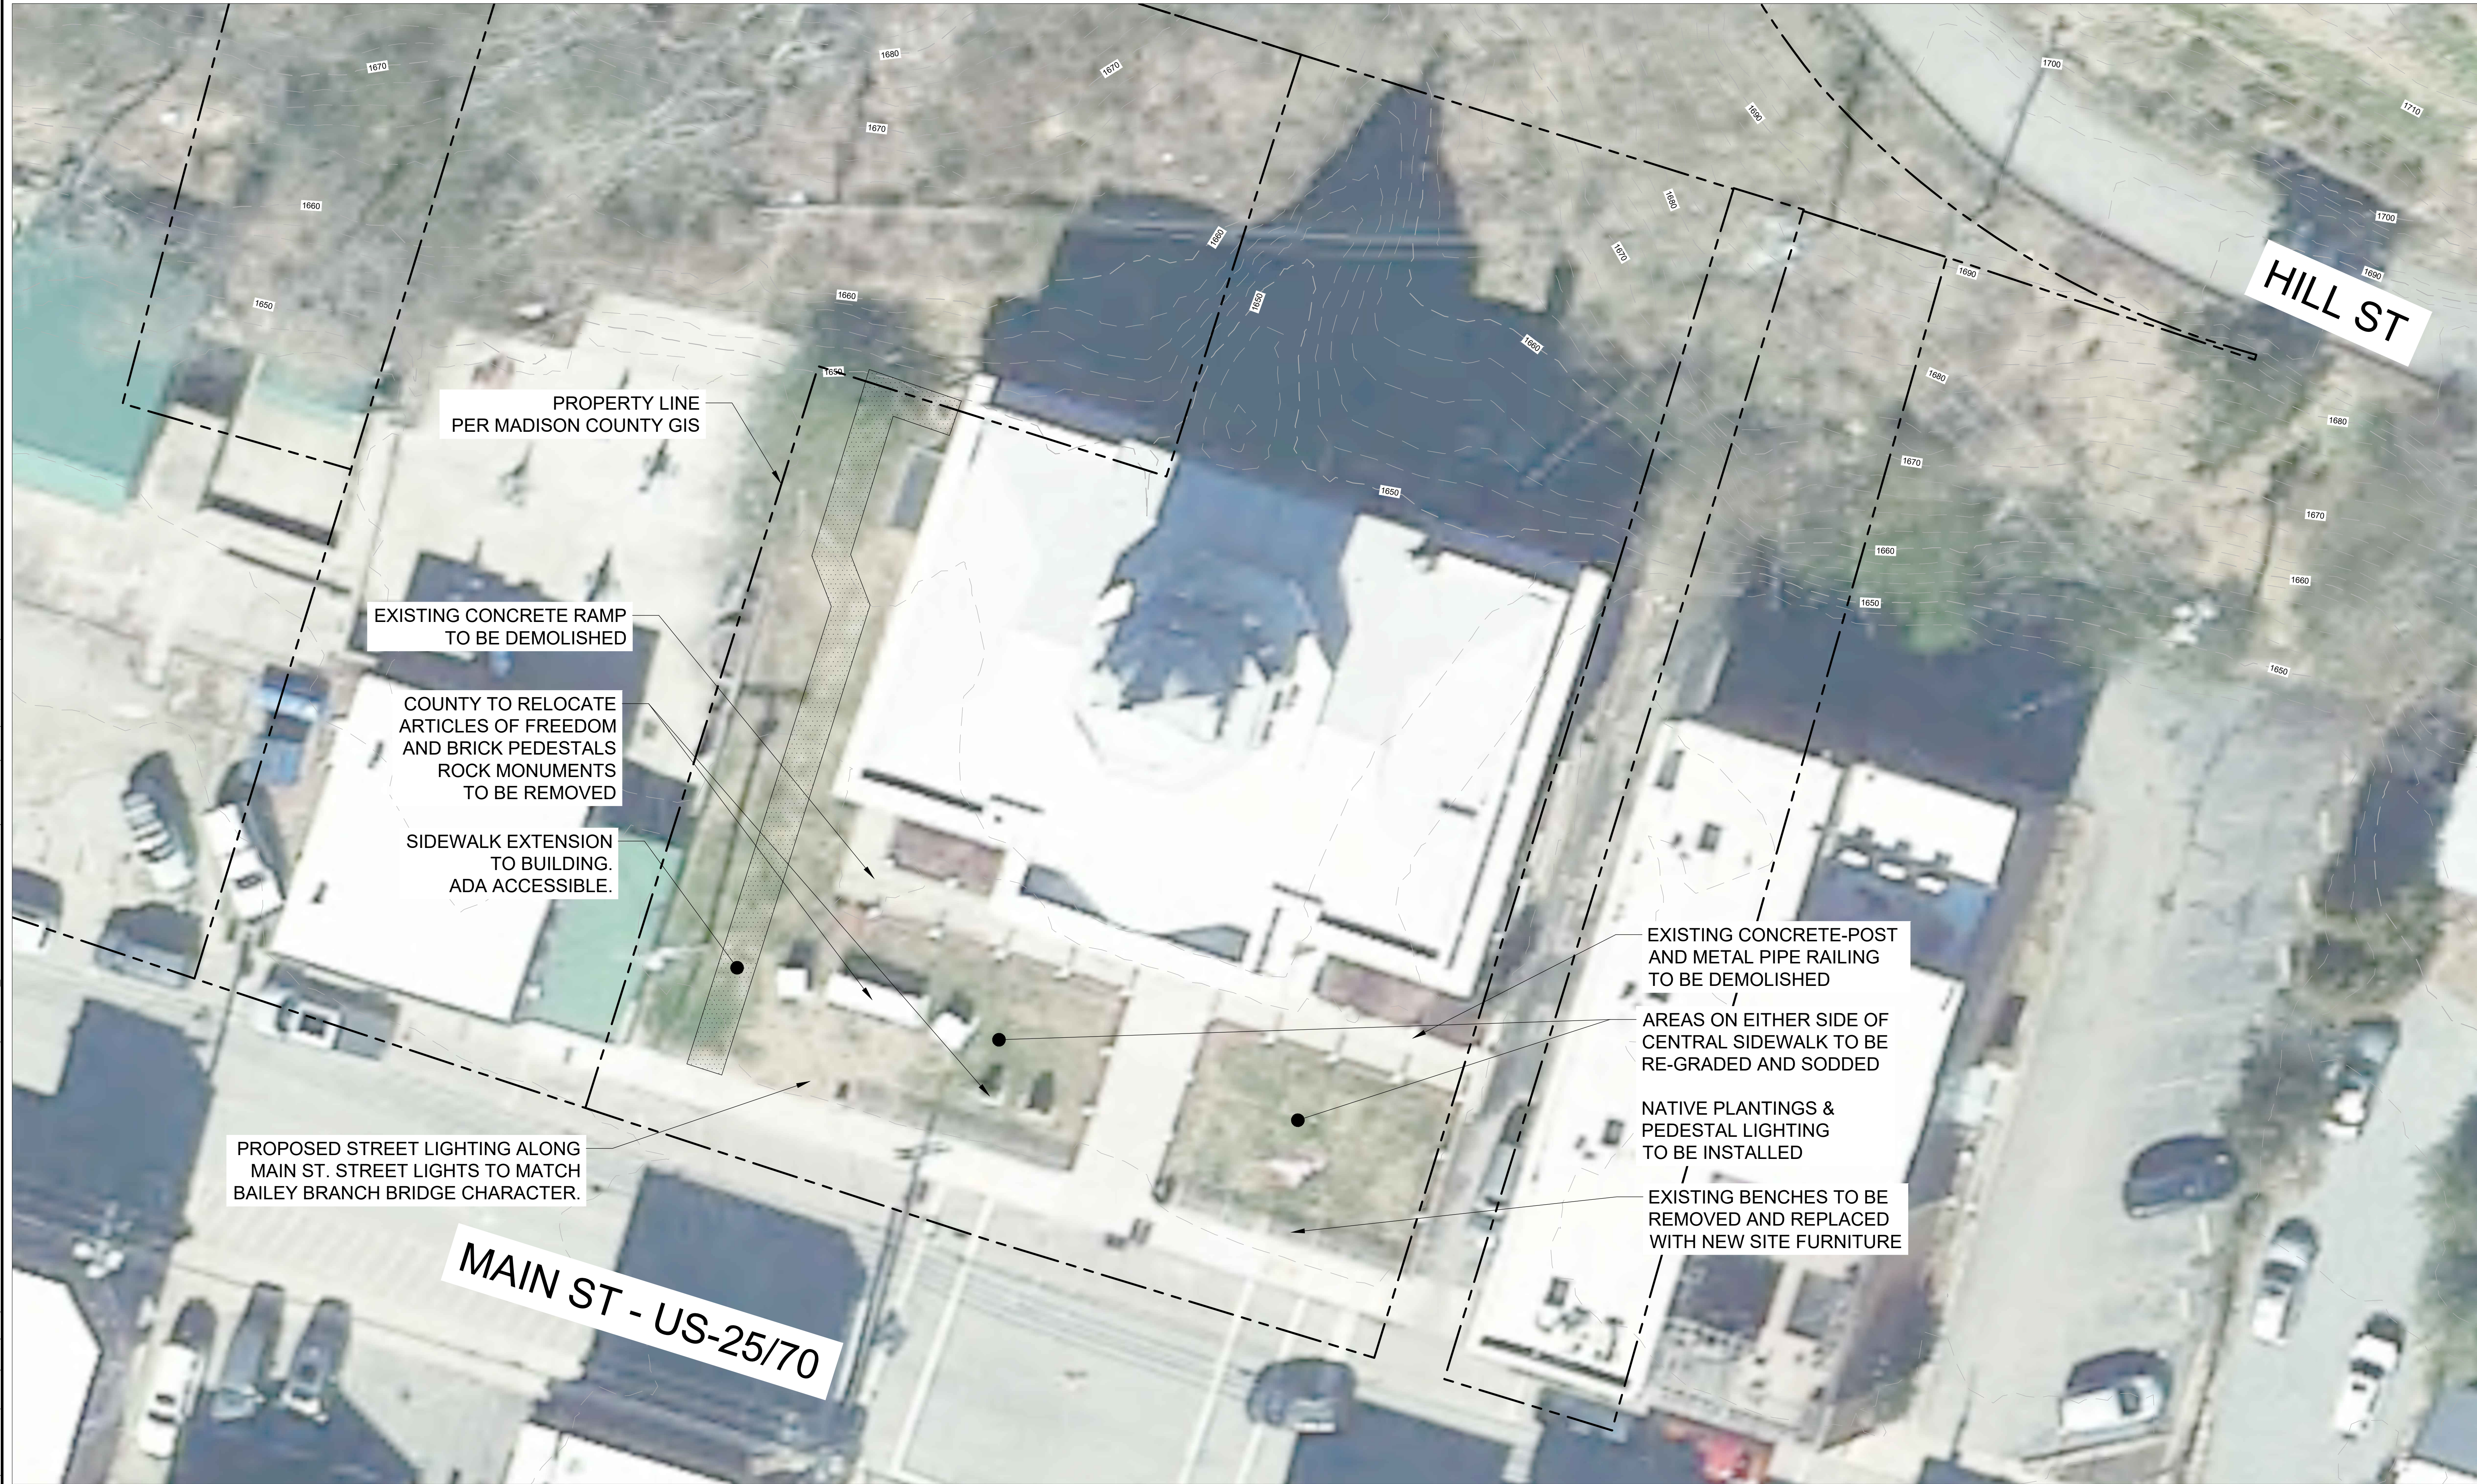
PLOTTED: 6/11/2026 4:20 PM
 BY: john atchley
 FILE: \\S:\SP-Rockhill\Projects\Lead_Development\Jobs\CPL_00053786 - Southwestern Commission On-Call_00053786_001 - Marshall_Courthouse\02 - DWG_Concept_Site_Plan.dwg
